2006 Annual Site Inspection and Monitoring Report for Uranium Mill Tailings Radiation Control Act Title II Disposal Sites

November 2006

Work Performed by S.M. Stoller Corporation under DOE Contract No. DE-AC01-02GJ79491
for the U.S. Department of Energy Office of Legacy Management, Grand Junction, Colorado

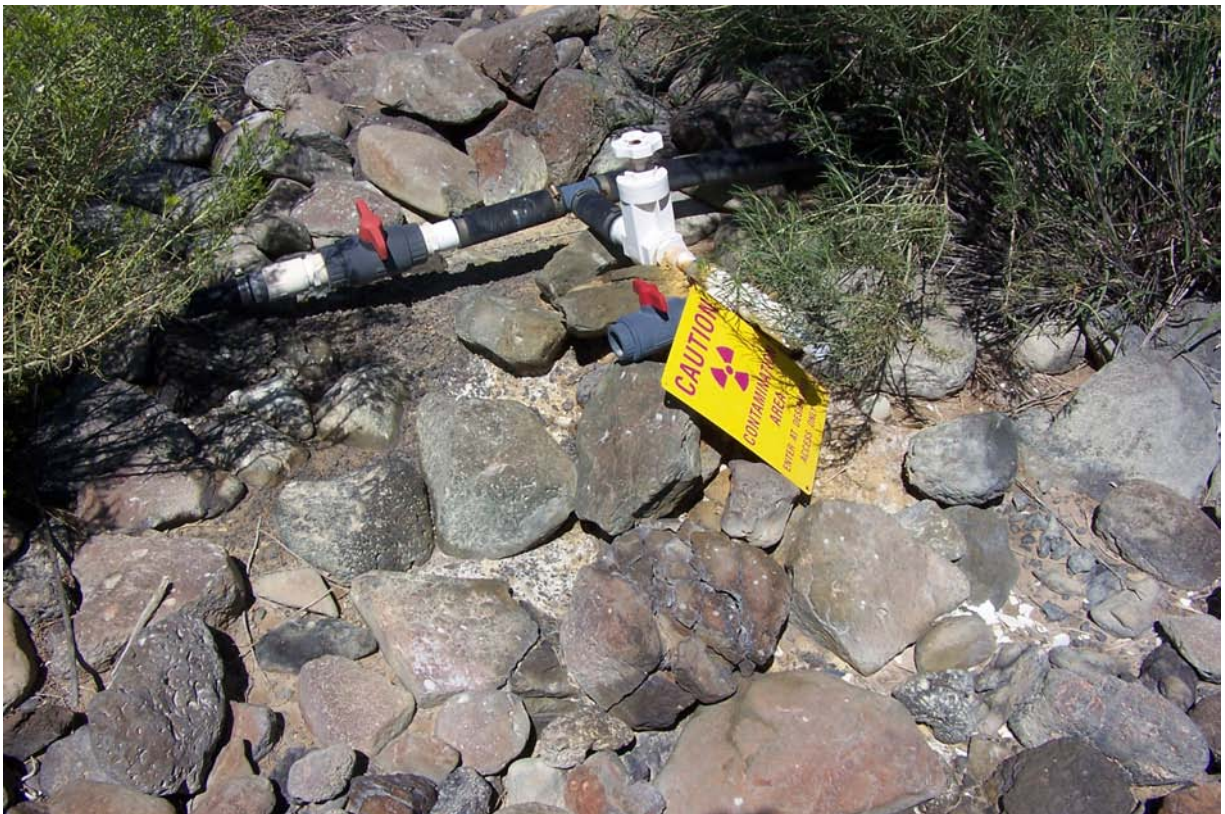
BAR 8/2006. PL-8. Contaminated drain outlet #5 at the base of the containment dam.

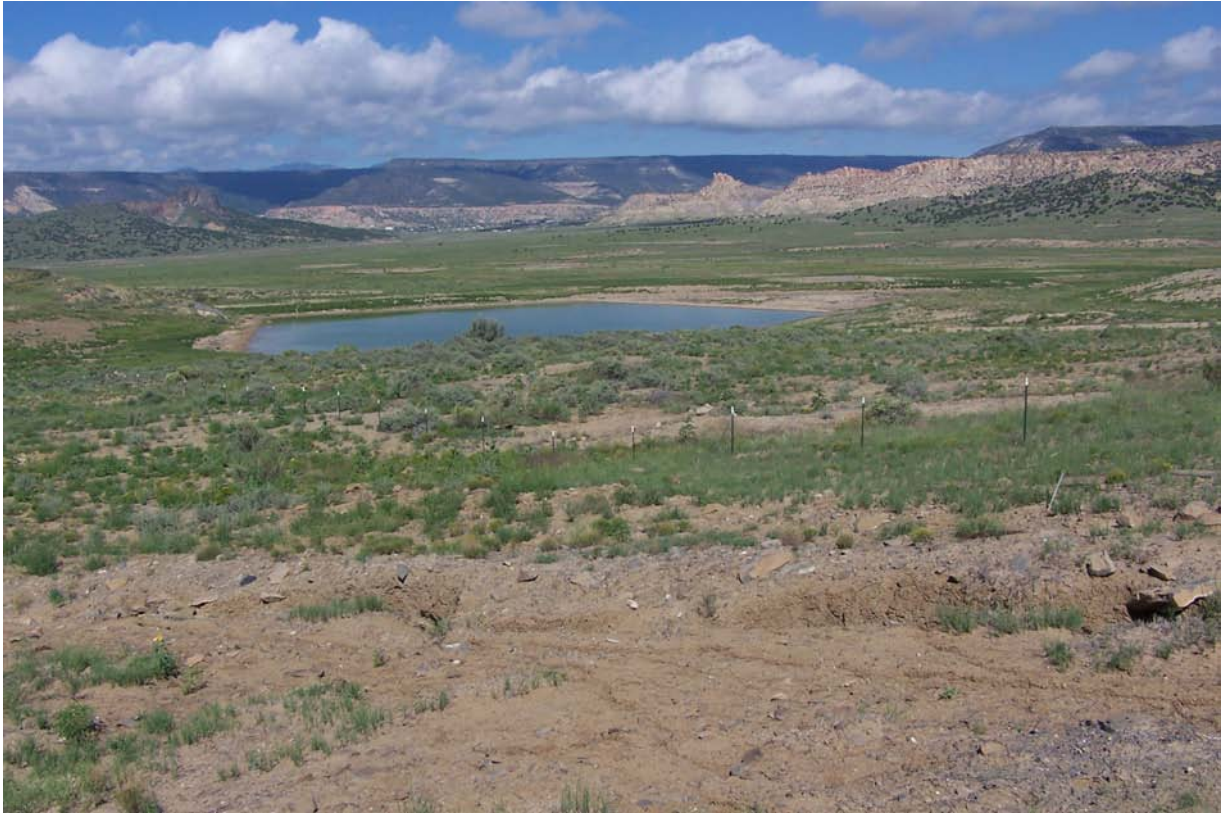
BAR 8/2006. PL-9. Standing water in the Sediment Trap.

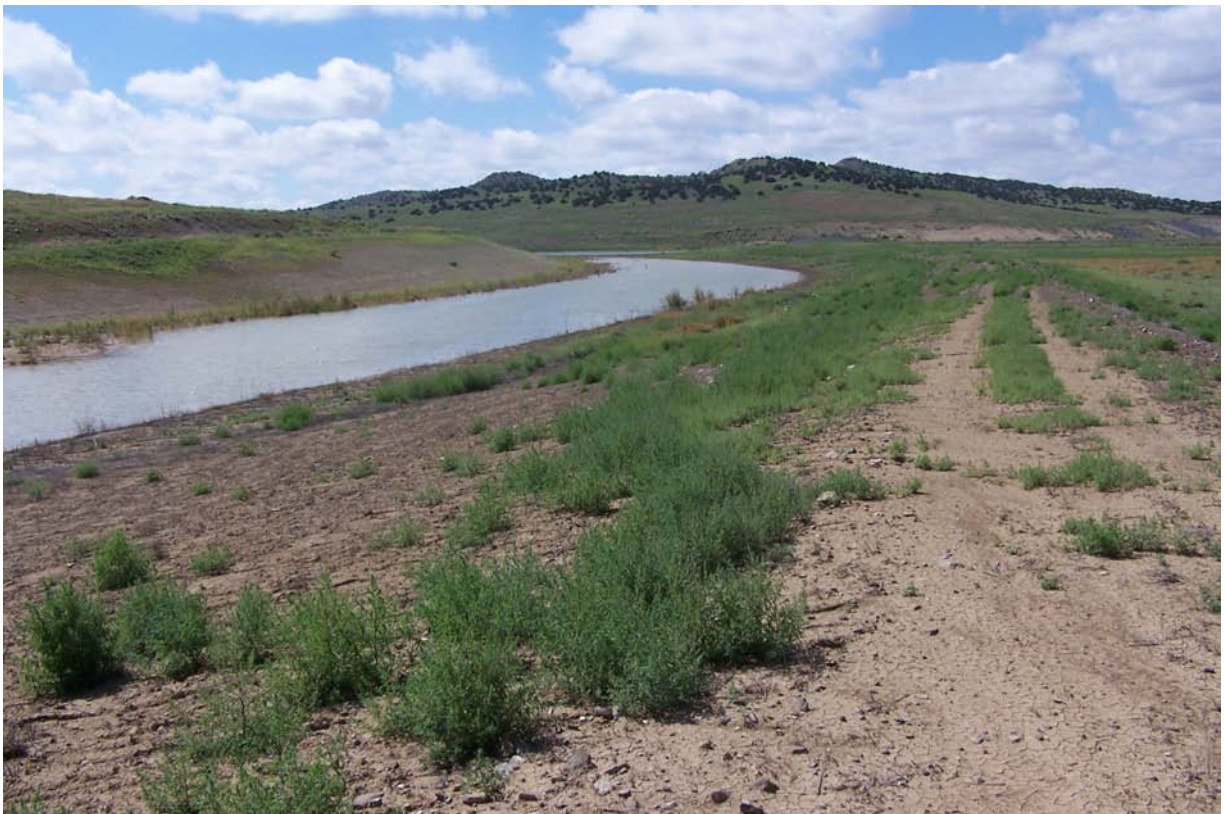
BAR 8/2006. PL-10. Standing water in the East Channel.

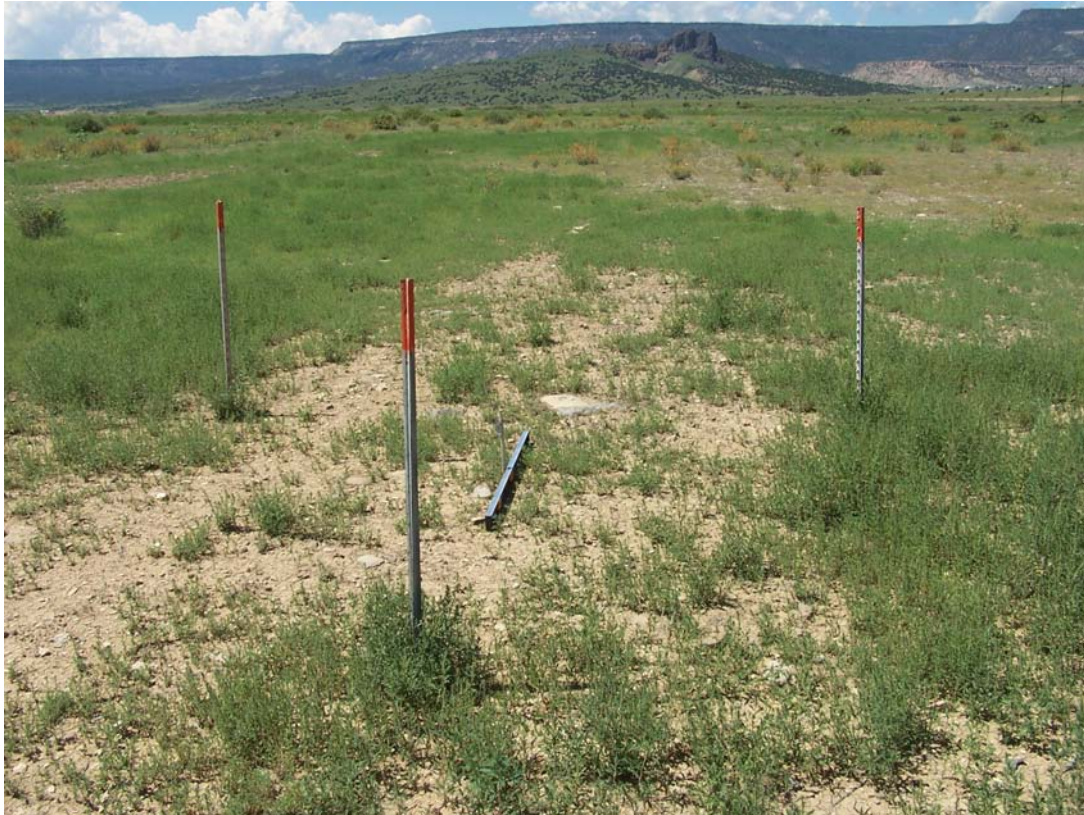
BAR 8/2006. PL-11. Erosion monitoring point and vegetation plot B2.

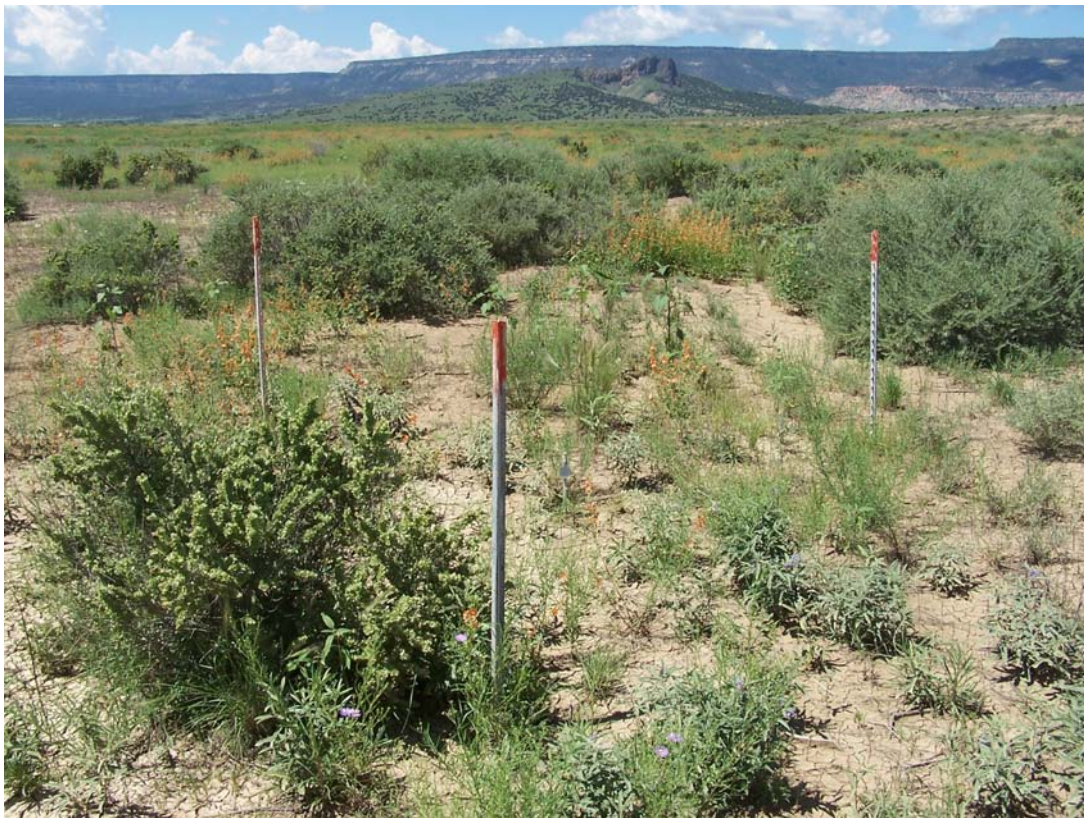
BAR 8/2006. PL-12. Erosion monitoring point and vegetation plot A3.

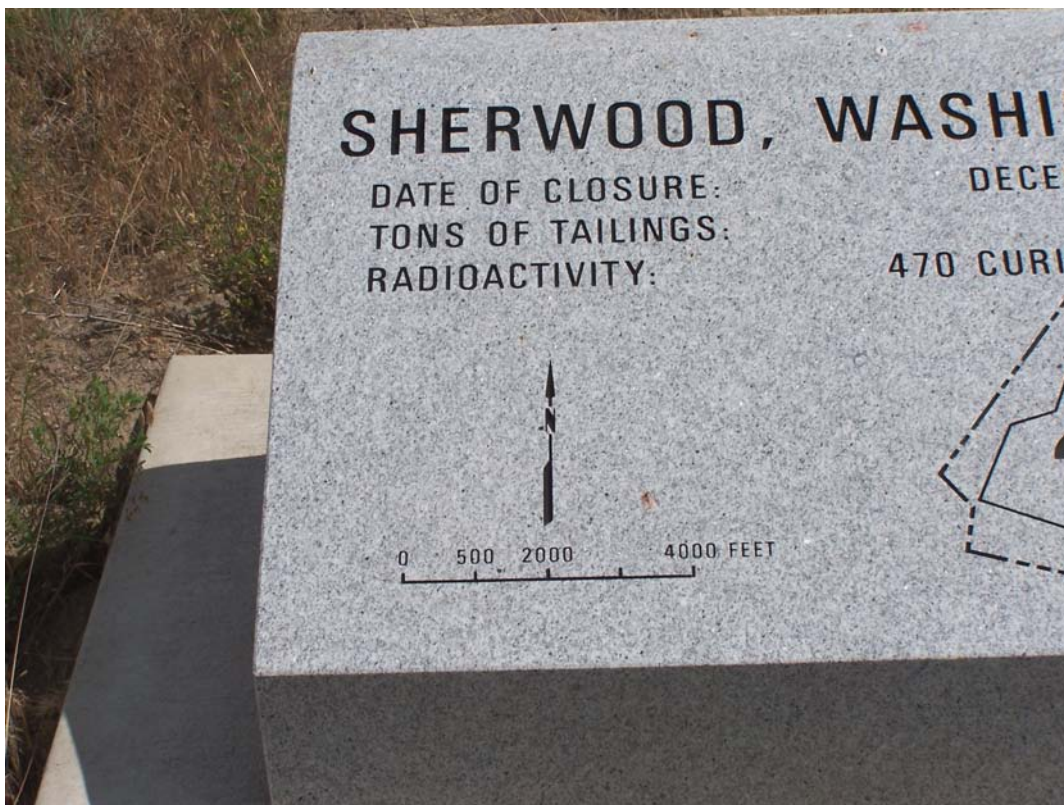
SHE 7/2006. PL-1. The site marker prior to repair of the scale.

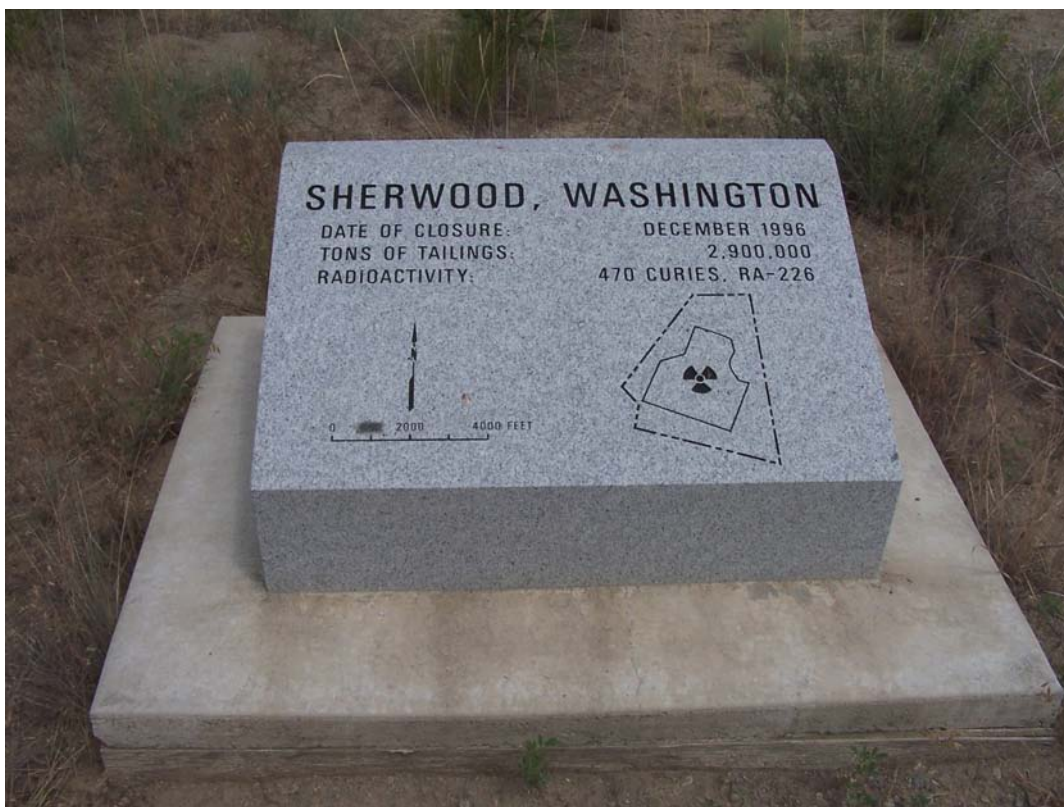
SHE 7/2006. PL-2. The site marker after repair of the scale.

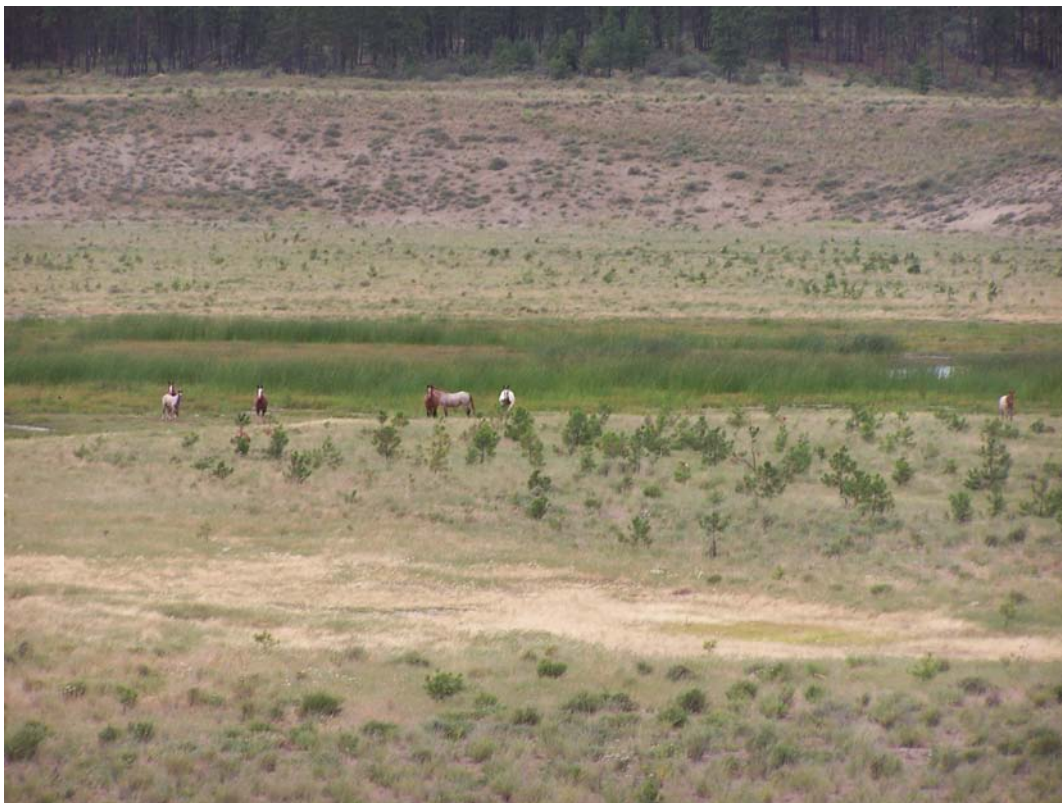
SHE 7/2006. PL-3. Wild horses at Pond 1 on the disposal cell top.

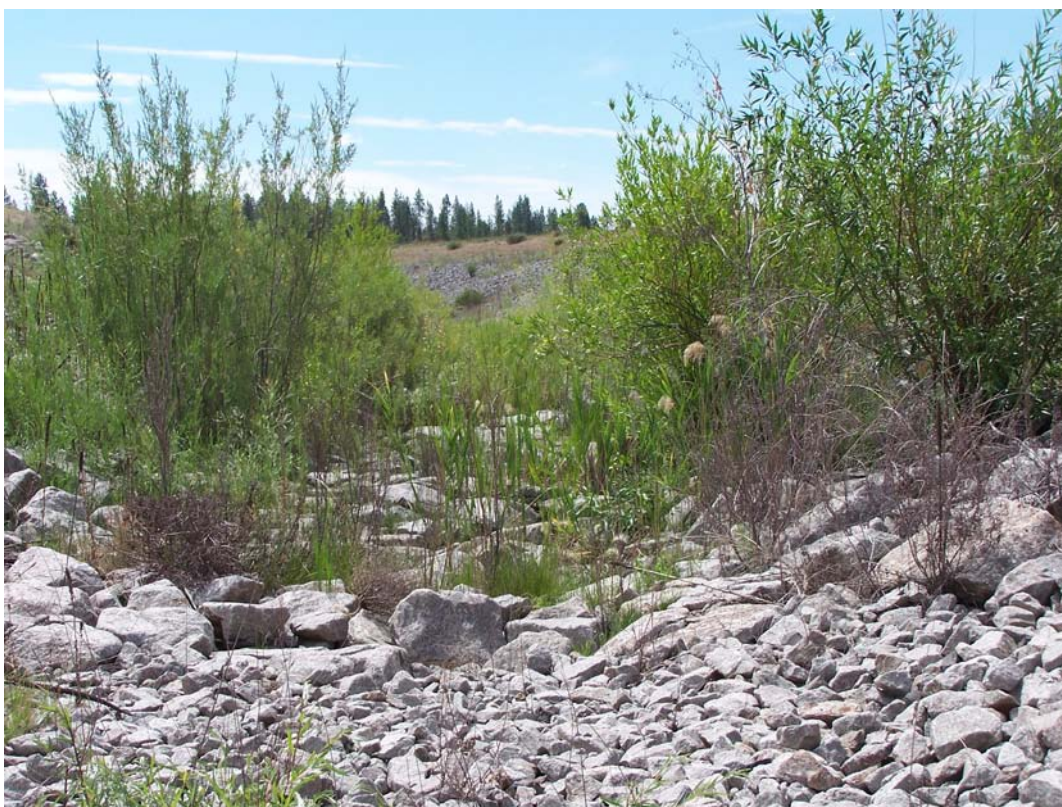
SHE 7/2006. PL-4. Wetland vegetation in the diversion channel.

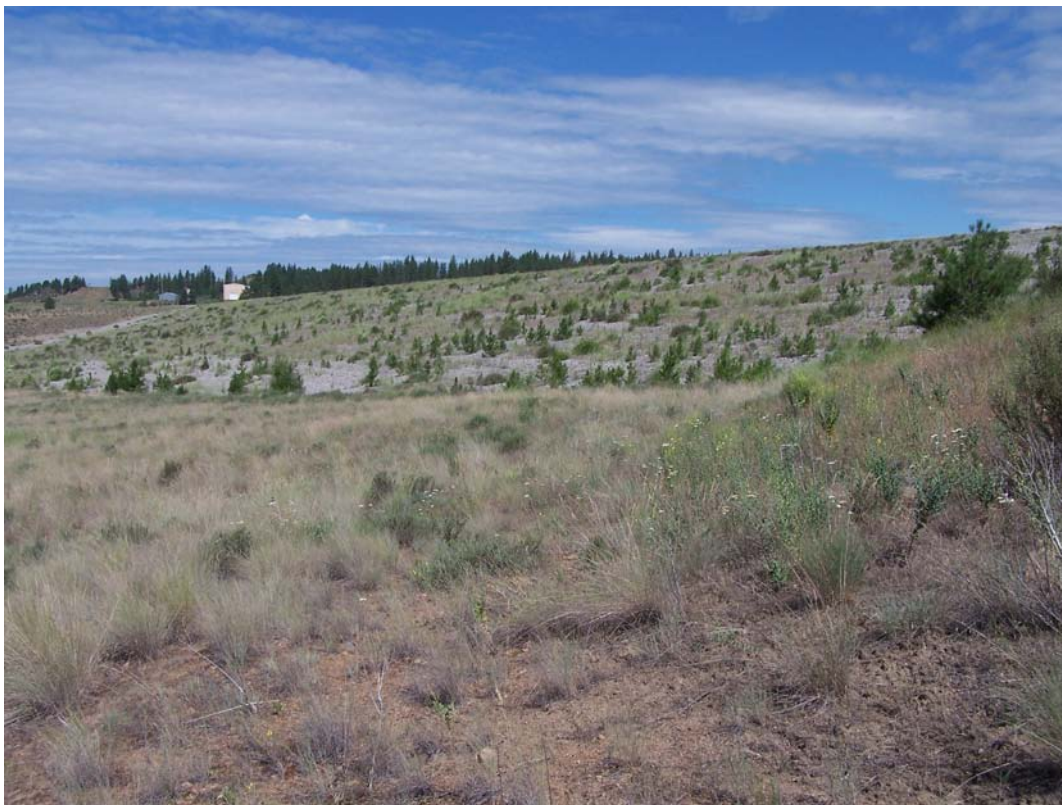
SHE 7/2006. PL-5. Vegetation on the face of the tailings dam.

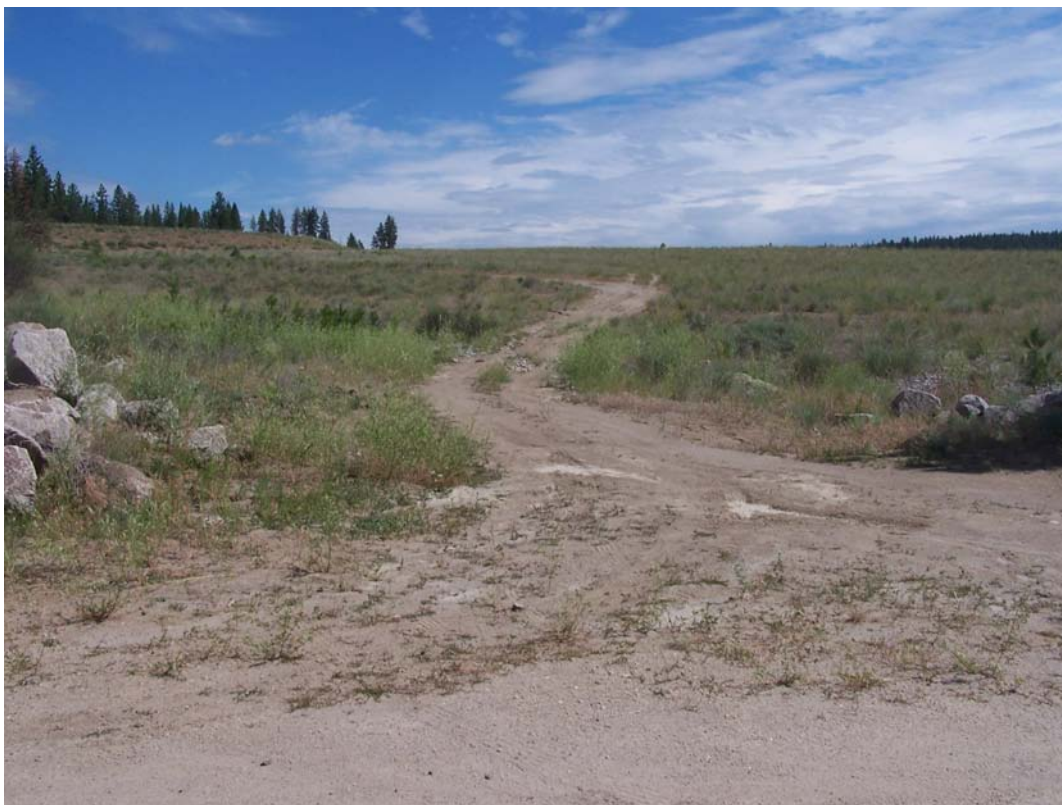
SHE 7/2006. PL-6. Widened access road entrance to accommodate logging operations.

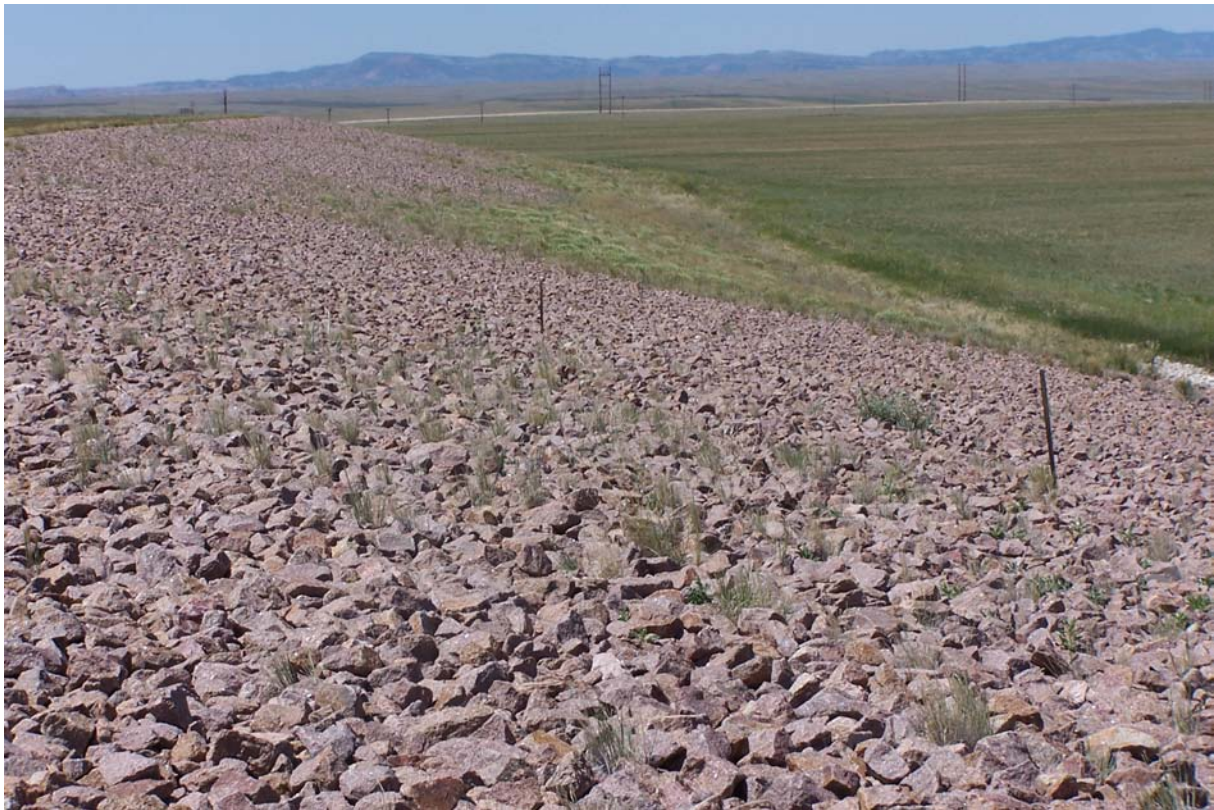
SBS 6/2006. PL-1. Riprap-armored slope separating the upper and lower disposal cell surfaces.

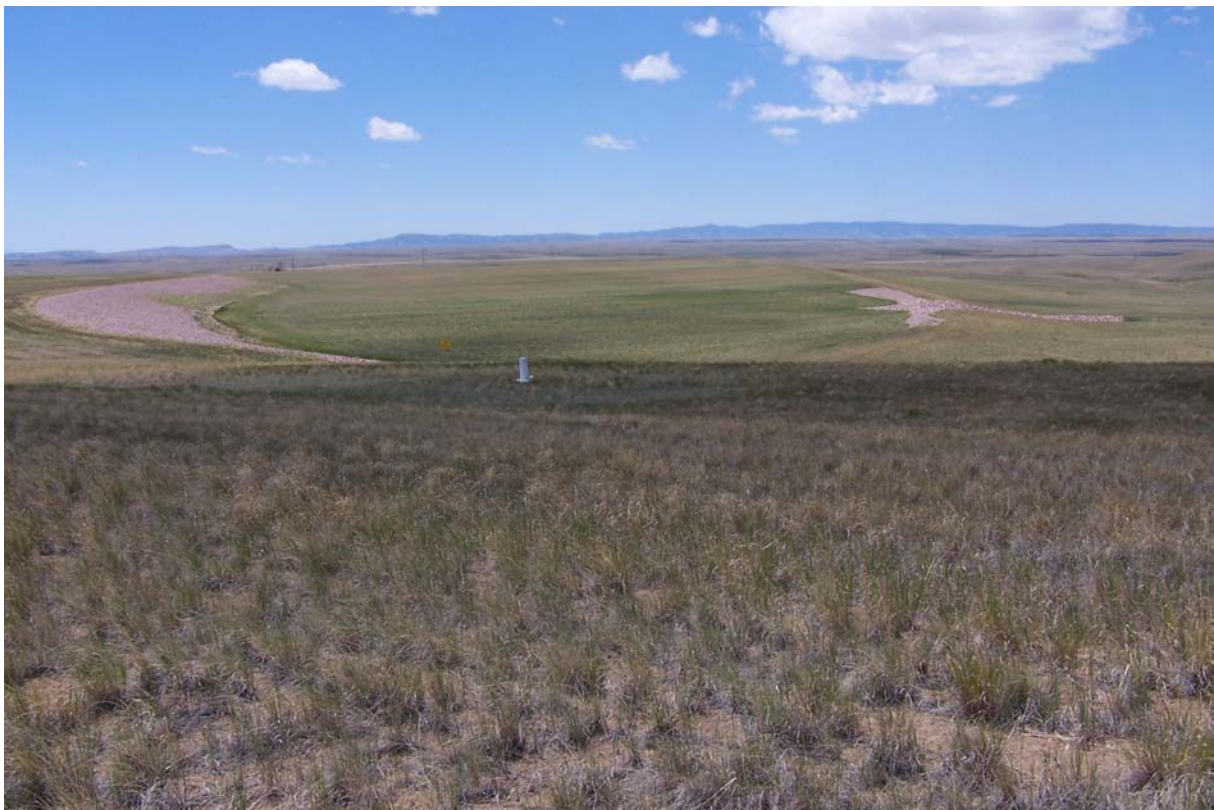
SBS 6/2006. PL-2. The lower surface of the disposal cell with monitor well 5-DC in the foreground.

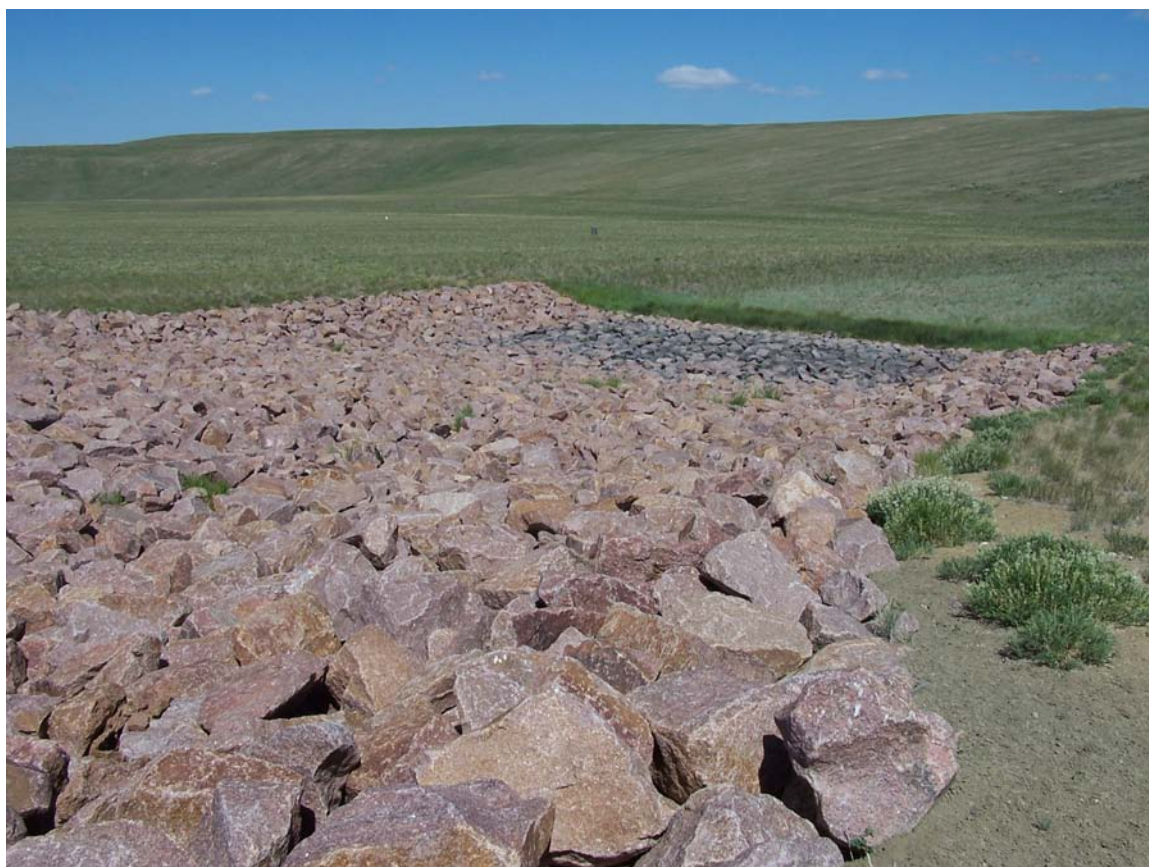
SBS 6/2006. PL-3. The north swale discharge point.

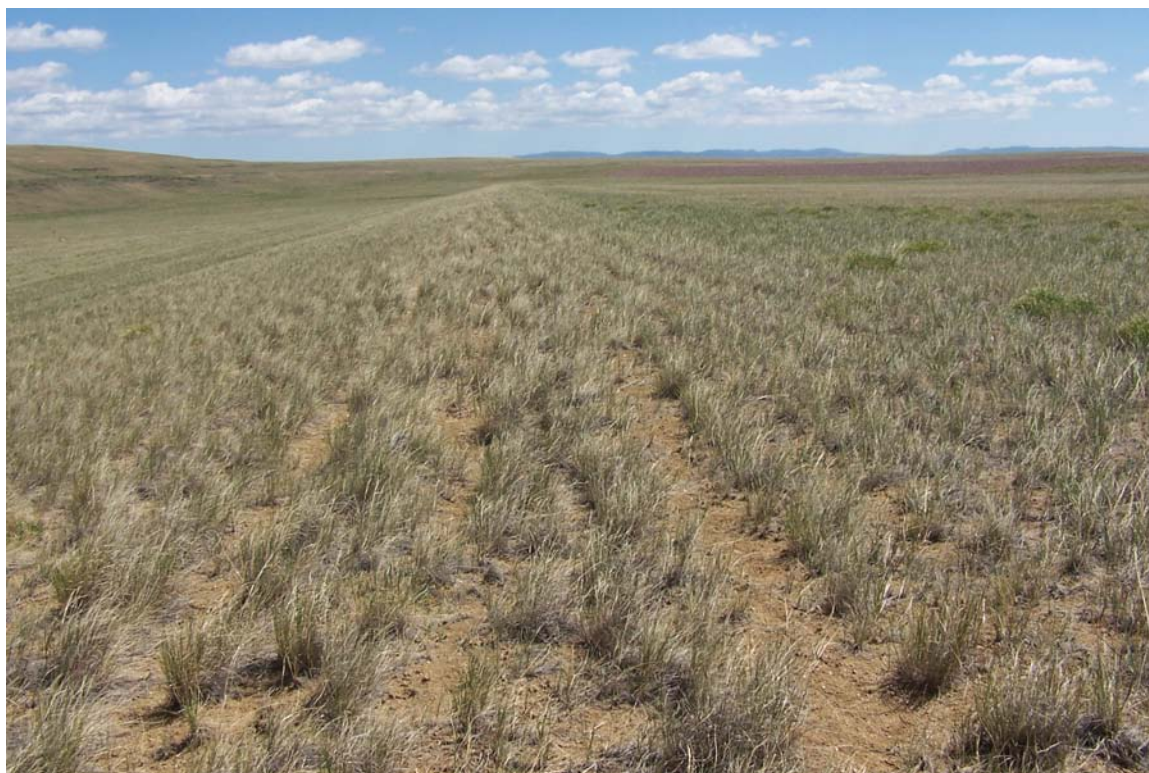
SBS 6/2006. PL-4. View northeast along the dam of the lower disposal cell surface.

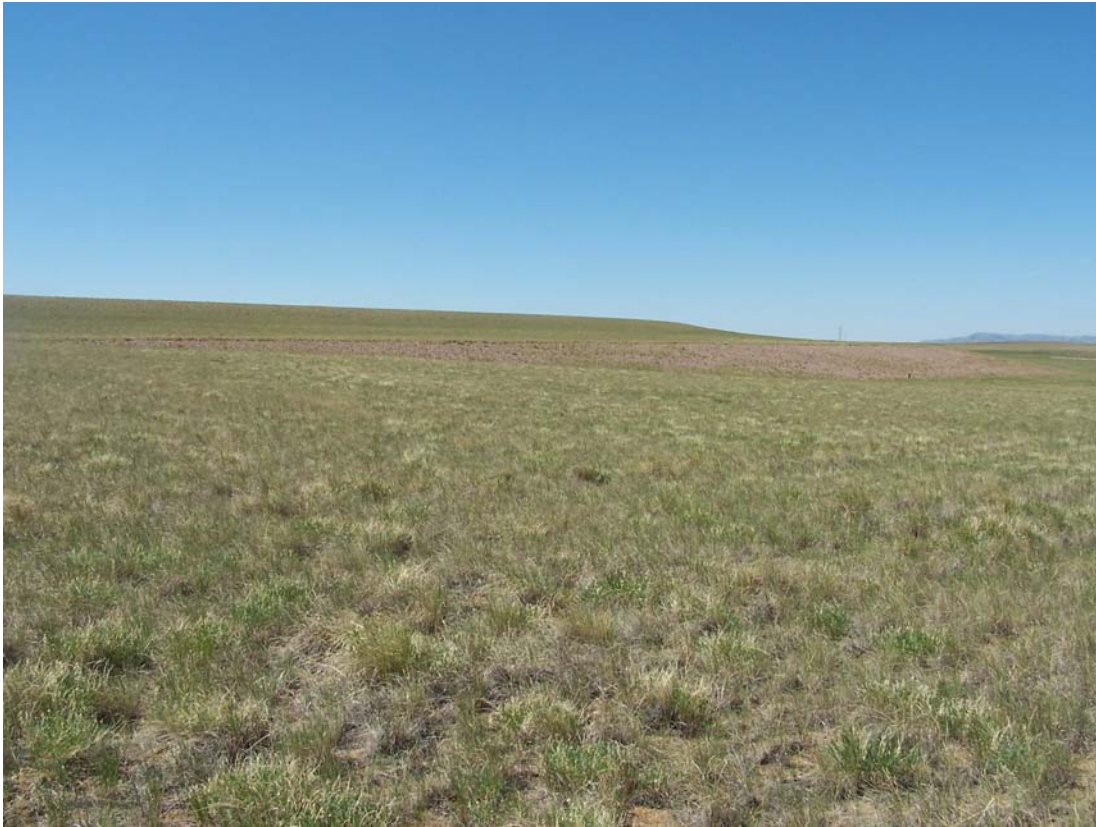
SBS 6/2006. PL-5. Riprap-armored toe of the dam outslope.

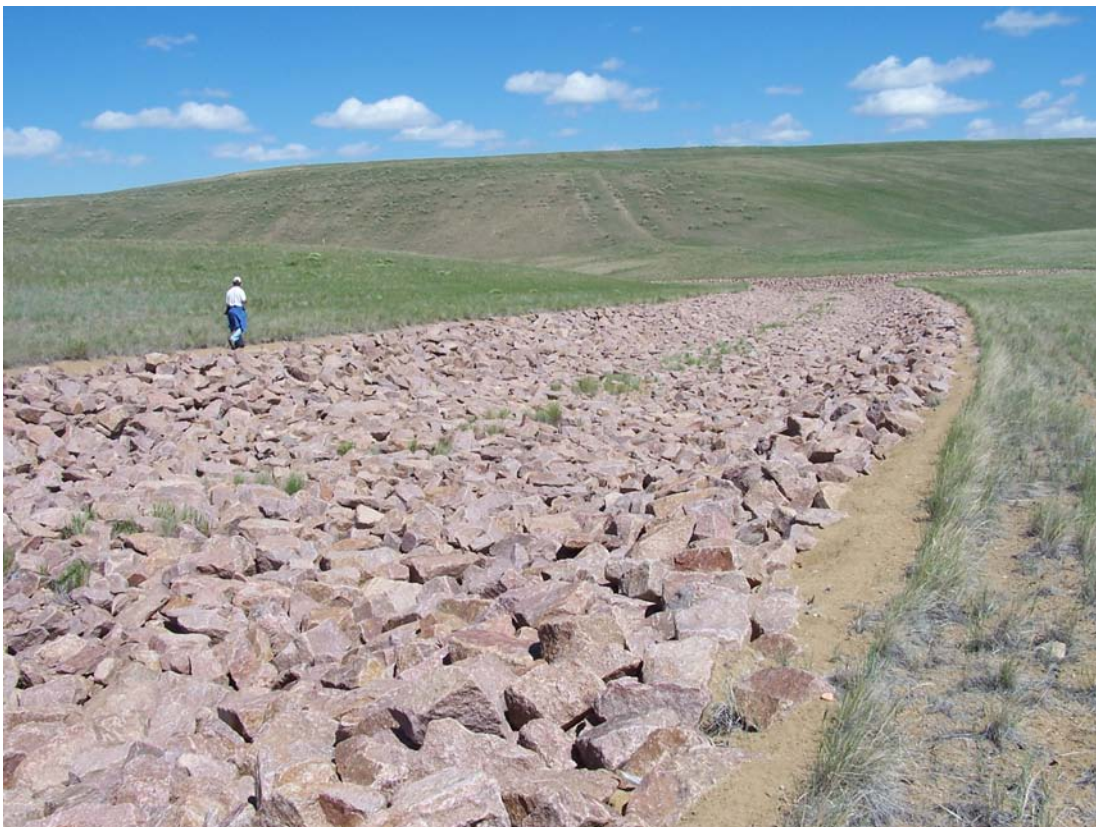
SBS 6/2006. PL-6. Riprap-armored drainage channel west of the disposal cell.

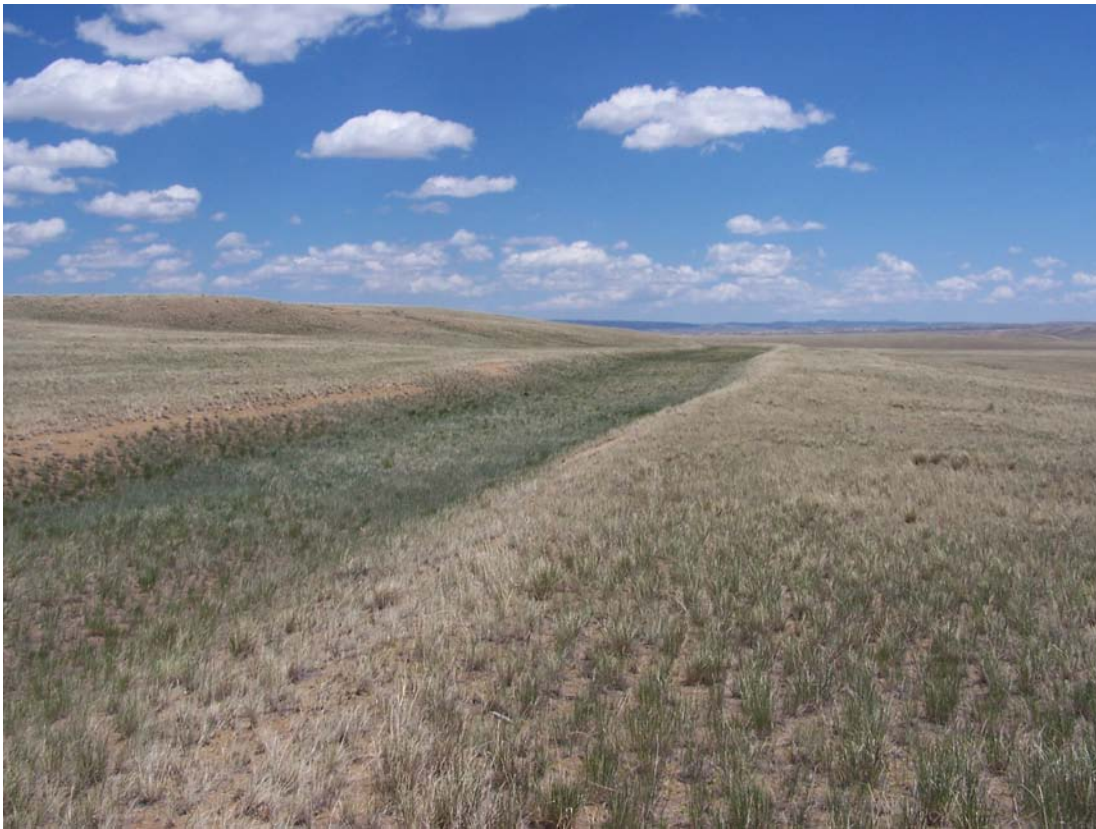
SBS 6/2006. PL-7. View downgradient (east) along the PMF channel.

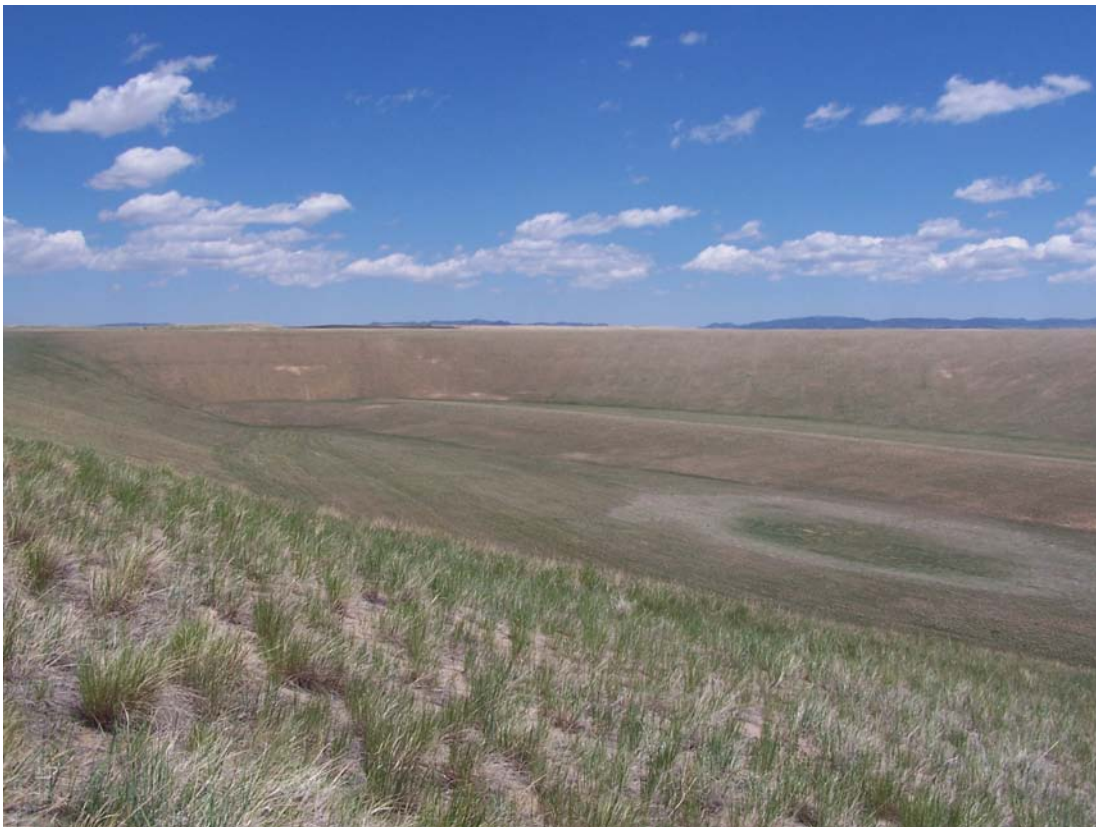
SBS 6/2006. PL-8. The north end of Pit 4.
